DYNAMIC SEALS FOR ADVANCED HYDRAULIC SYSTEMS

Robert B. Olsen
Vought Corporation
P.O. Box 225907
Dallas, Texas 75265

August 1981

Final Report for Period July 1978 - March 1981

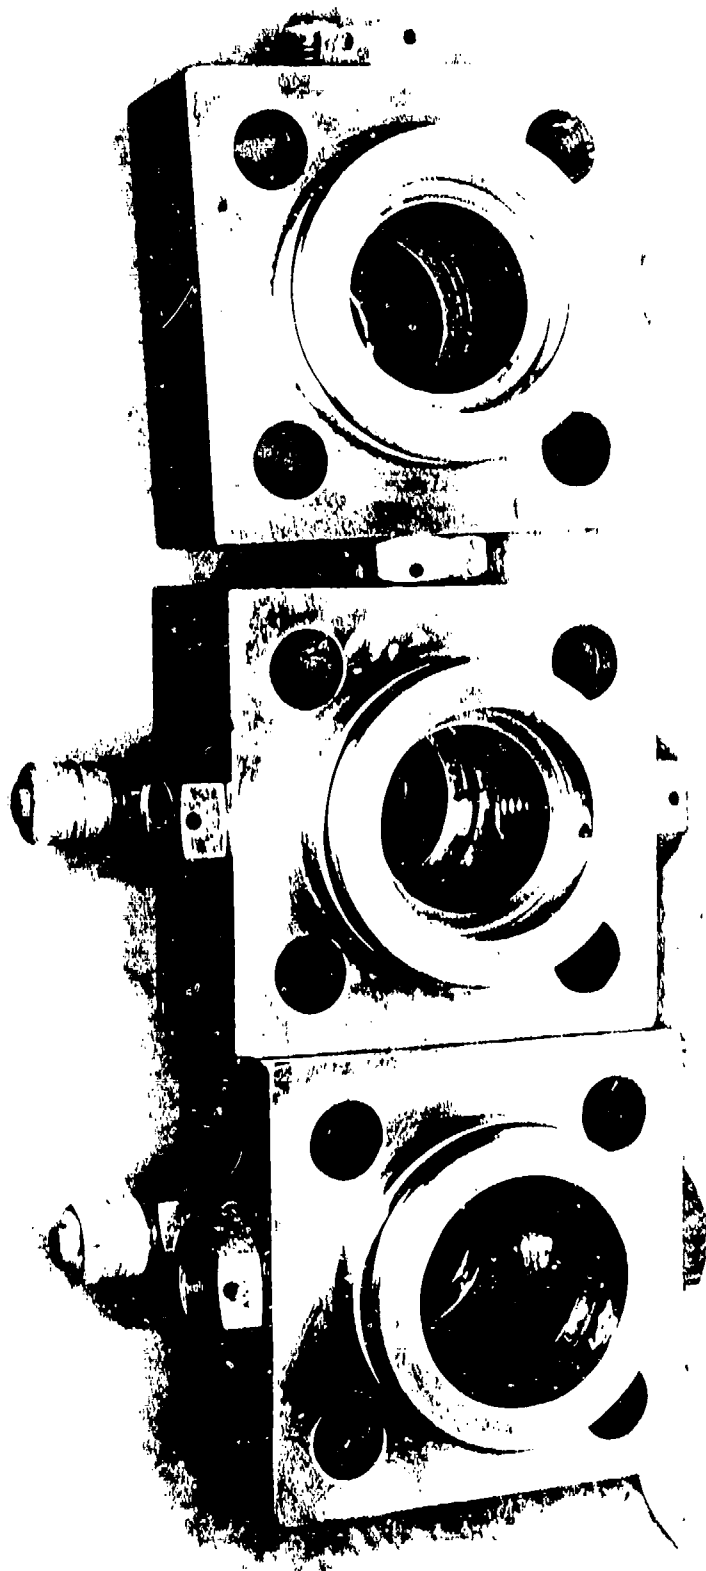
Upon disassembly of each two stage rod seal installation, an accumulation of soft, black oily residue was noted in the cavity between seals in all cases. This appears to be a normal occurrence and is not considered to be detrimental. Figure 121 shows three end caps and the appearance of the residue.

Figure 121. End Caps in Two Stage Rod Seal Screening Test. Normally have soft oily seal residue between seals.

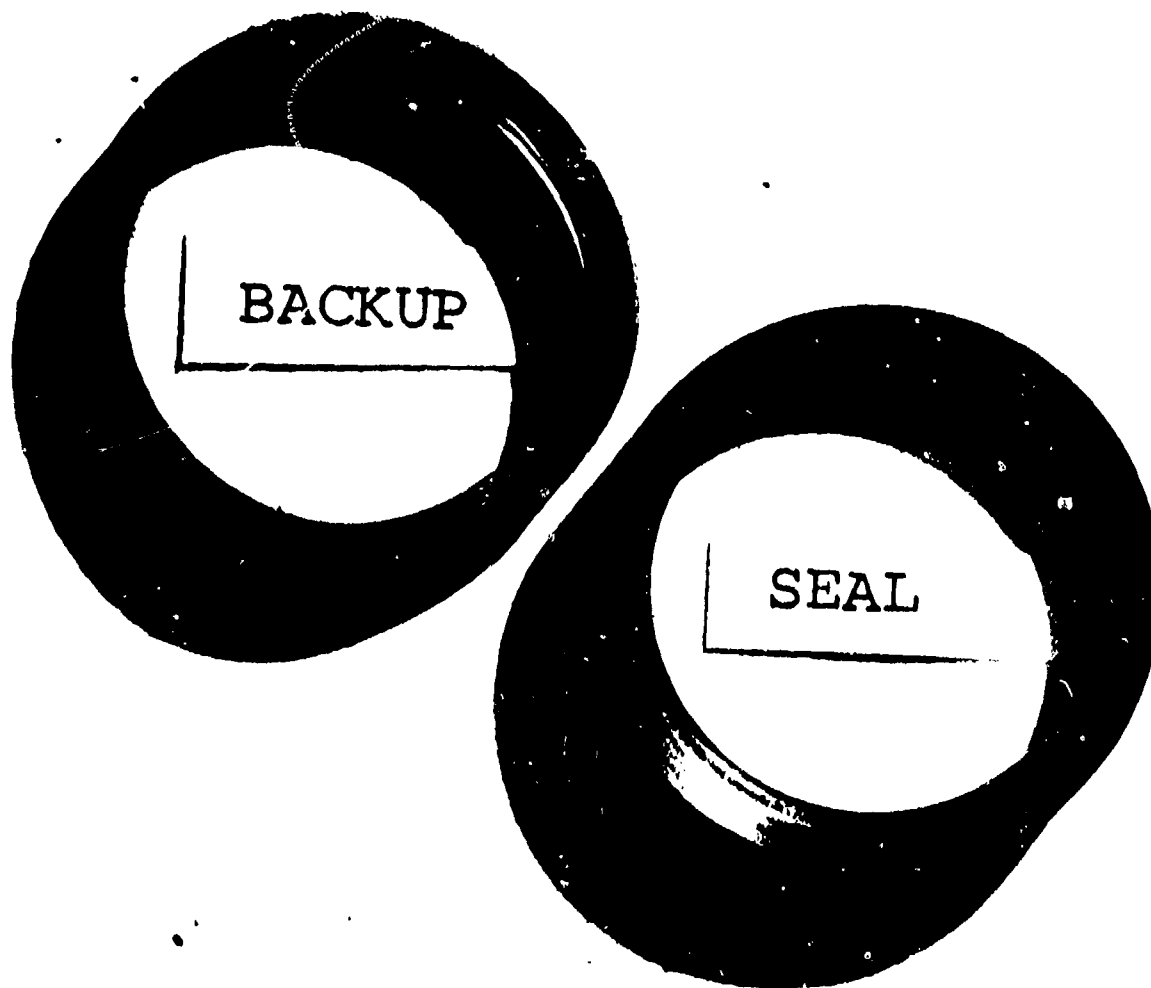
TRS4-SV-3R-TR
1ST STAGE

RESULTS: See Figures 132 and 133. The inboard and outboard seals had no appearance of wear. The backups inner diameters of .9903 and .996 had yielded to .998 corresponding to rod diameter. Rod wear was very light. There was no evidence of external leakage. Approximately 2 to 3 ml of thick black residue had accumulated between the seals. Diametral clearance for the outer seal was .0031 and for the inner seal was .0035.

Figure 132. Candidate TRS4-SV (1st Stage) After Two Stage Rod Seal Screening Test. Trapezoid shape elastomer and backup had very little wear.

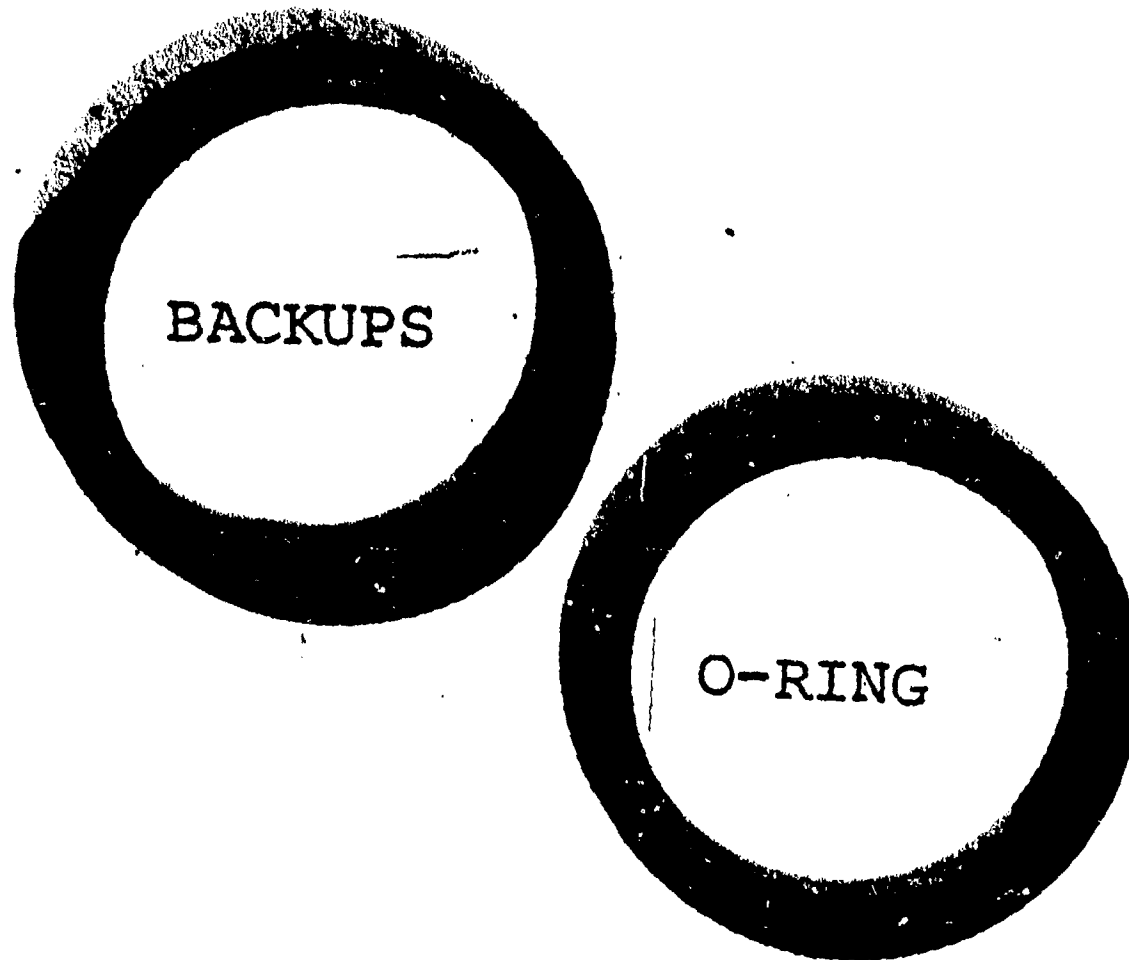
TRS6-UV-8R-TR
2ND STAGE

RESULTS: See Figures 134 and 135. Both inboard and outboard O-rings were in excellent condition. The backup showed some wear with the outer backup on the inboard seal showing the most wear. Cross-section was .1214 before test and .1033 after test. There was no rod wear. There was no external leakage. The cavity between the seals had an accumulation of black residue similar to that found in other end caps. Diametral clearance for the outboard seal was .0033 and for the inboard seal was .0023.

Figure 135. Candidate TRS6-UV (2nd Stage) After Two Stage Rod Seal Screening Test. There was no external leakage with this two stage installation.

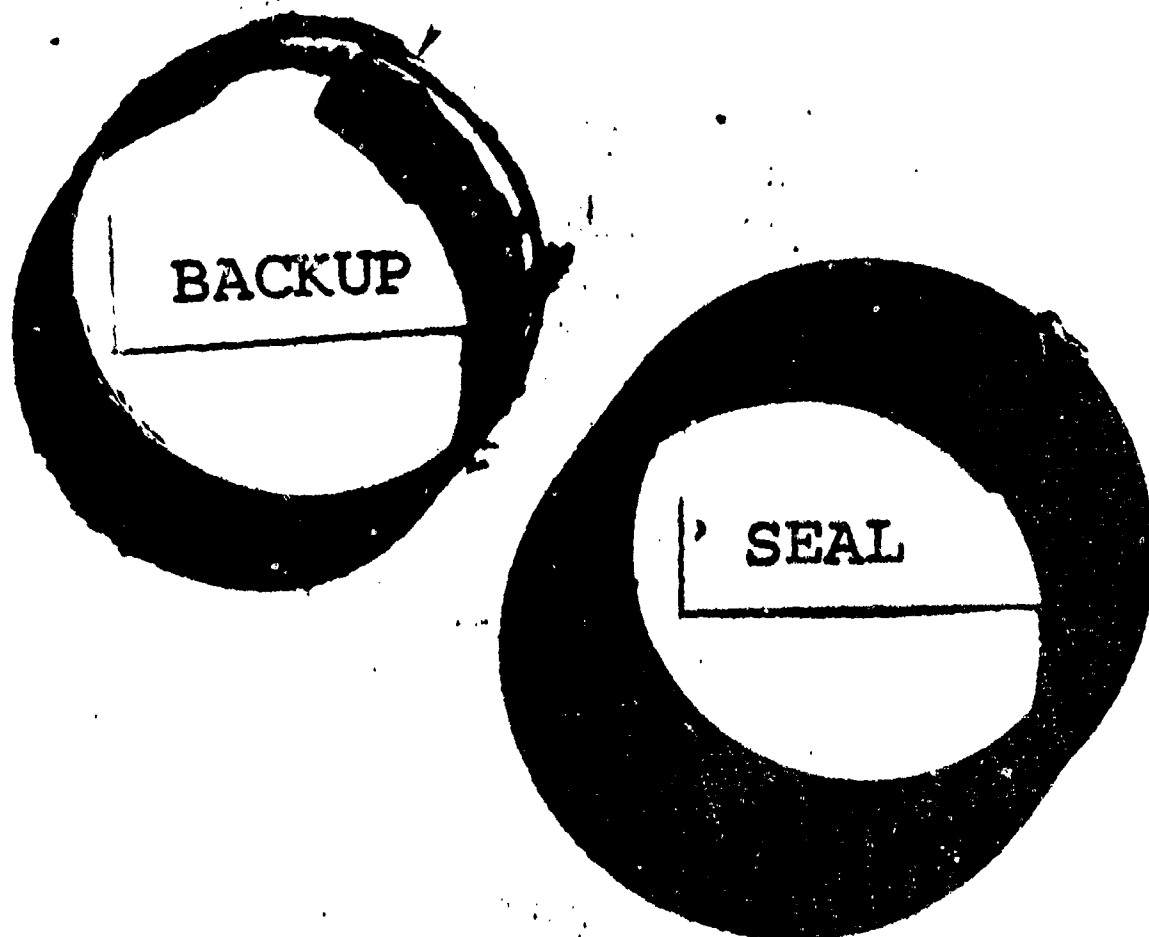
TRS8-UV-10R-TR
1ST STAGE

RESULTS: See Figures 136 and 137. The backup on the inboard seal was worn thru at one location. The backup on the outboard seal was severely worn completely around its circumference and the sealing lip on the elastomer was fatiguing and tearing. This seal leaked erratically throughout the test for a total of over 372 ml. The rod surface finish had a slight "lapped" appearance. Diametral clearance for the inboard seal was .0027 and for the outboard seal was .0052.

Figure 136. Candidate TRS8-UV (1st Stage) After Two Stage Rod Seal Screening Test. Arrow denotes area of backup which has worn through.

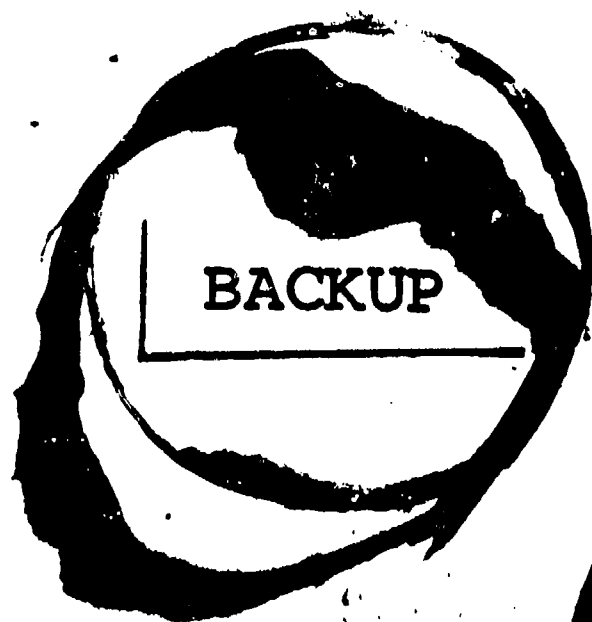
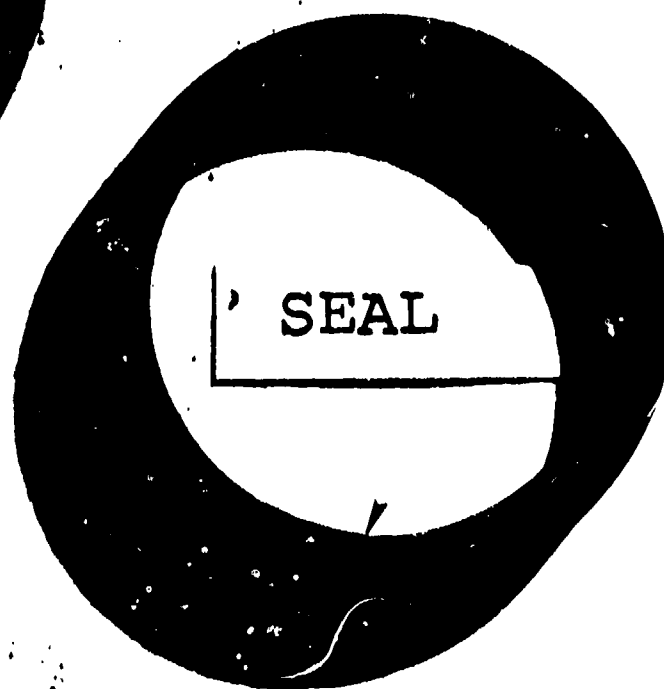
TRS8-UV-10R-TR
2ND STAGE

Figure 137. Candidate TRS8-UV (2nd Stage) After Two Stage Rod Seal Screening Test. Arrow shows where tear is beginning on sealing lip.

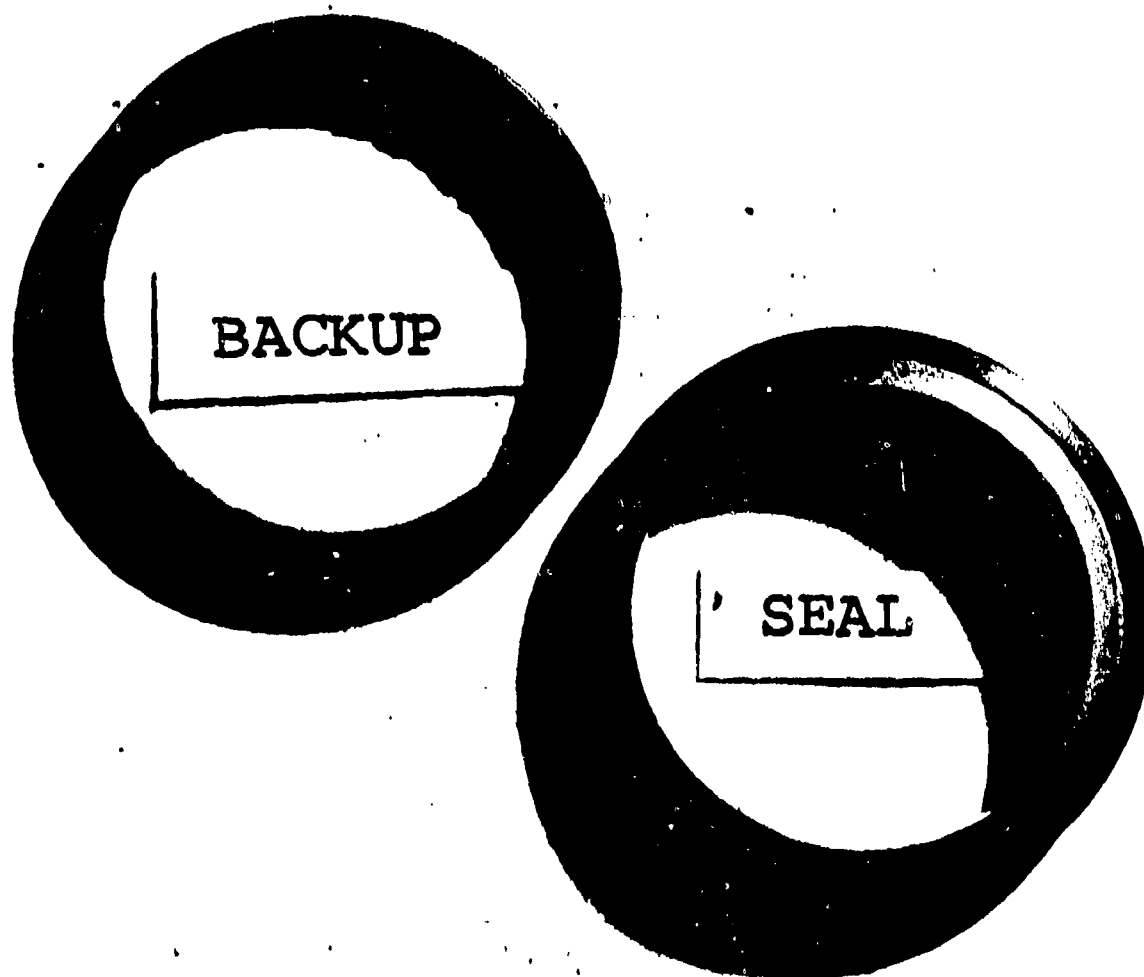
TRS13-V-5R-TR
1ST STAGE

RESULTS: See Figures 138 and 139. Both the inboard and outboard seal were in excellent condition. The ID of the cap seals was less than .982 before test and .9903 to .996 after test which was less than the rod diameter of .998. The rod had light wear. Wear was not uniform around the circumference of the rod indicating not all side loading was eliminated on the cylinder. There was evidence of external leakage. Diametral clearance was .0024 for both inboard and outboard seals.

Figure 138. Candidate TRS13-V (1st Stage) After Two Stage Rod Seal Screening Test. Seal and backup were in excellent condition after test.

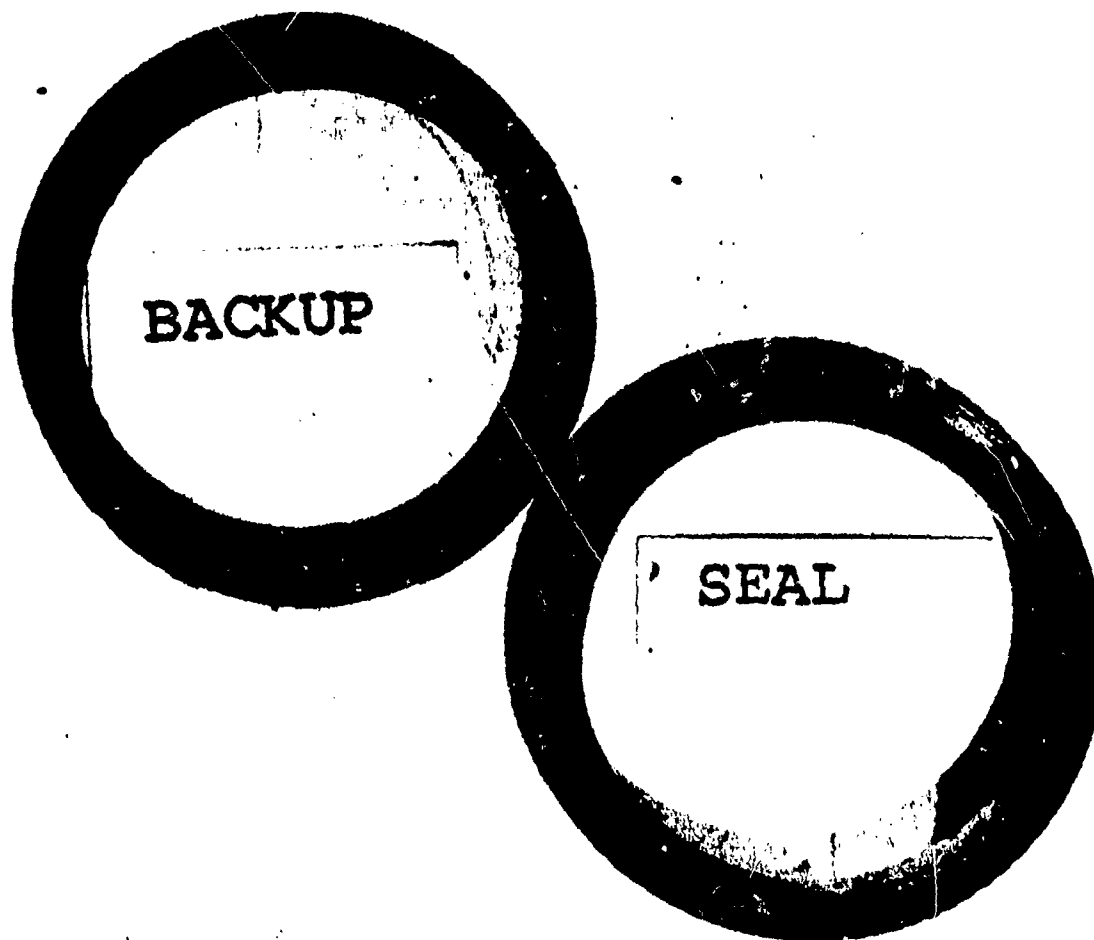
TRS13-V-51 (TV)
2ND STAGE

Figure 139. Candidate TRS13-V (2nd Stage) After Two Stage Rod Seal Screening Test. Seal and backup were in excellent condition after test.

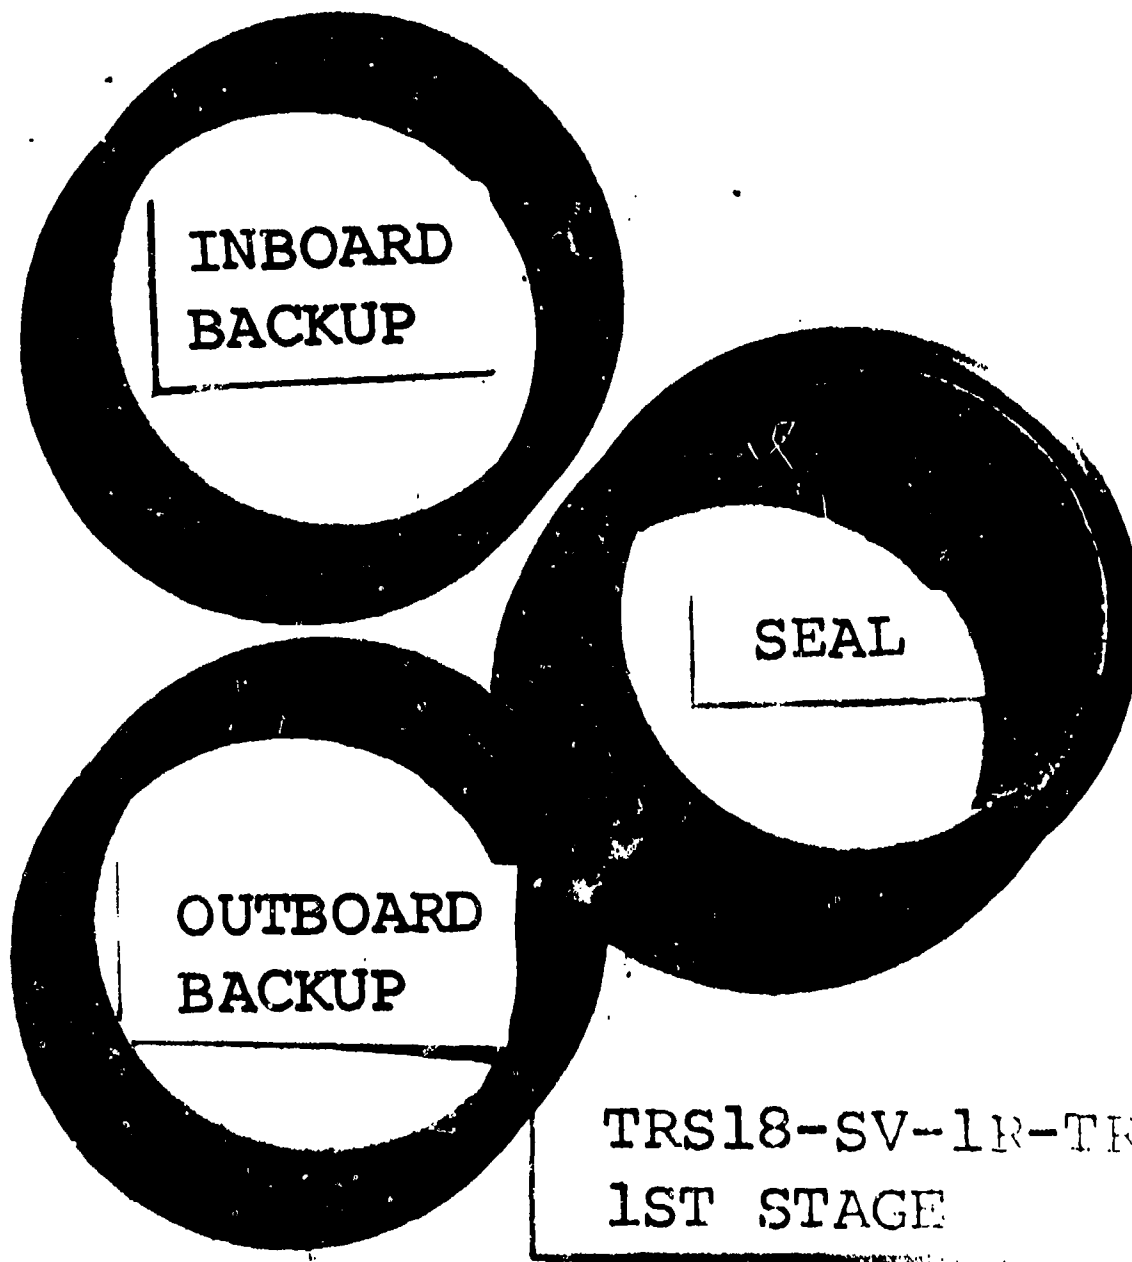
RESULTS: See Figures 140 and 141. Inboard seal had minimum wear with no evidence of cracking or splitting around circumference on inner diameter of cap seal. Outboard seal had minimum wear, with a very shallow axial wear pattern around the inner diameter sealing surface. The staged nylon/TFE backups showed no wear. The rod had a light to moderate axial wear pattern around the circumference corresponding to the areas most frequently contacted by the nylon backup rings on the outboard seal. Diametral clearance for the outboard seal was .0035 and for the inboard seal was .0025. There was evidence of some external leakage. See separate discussion of leakage collection in paragraph 7.0. Two to four ml of soft black residue had accumulated between seals.

Figure 140. Candidate TRS18-SV (1st Stage) After Two Stage Rod Seal Screening Test.

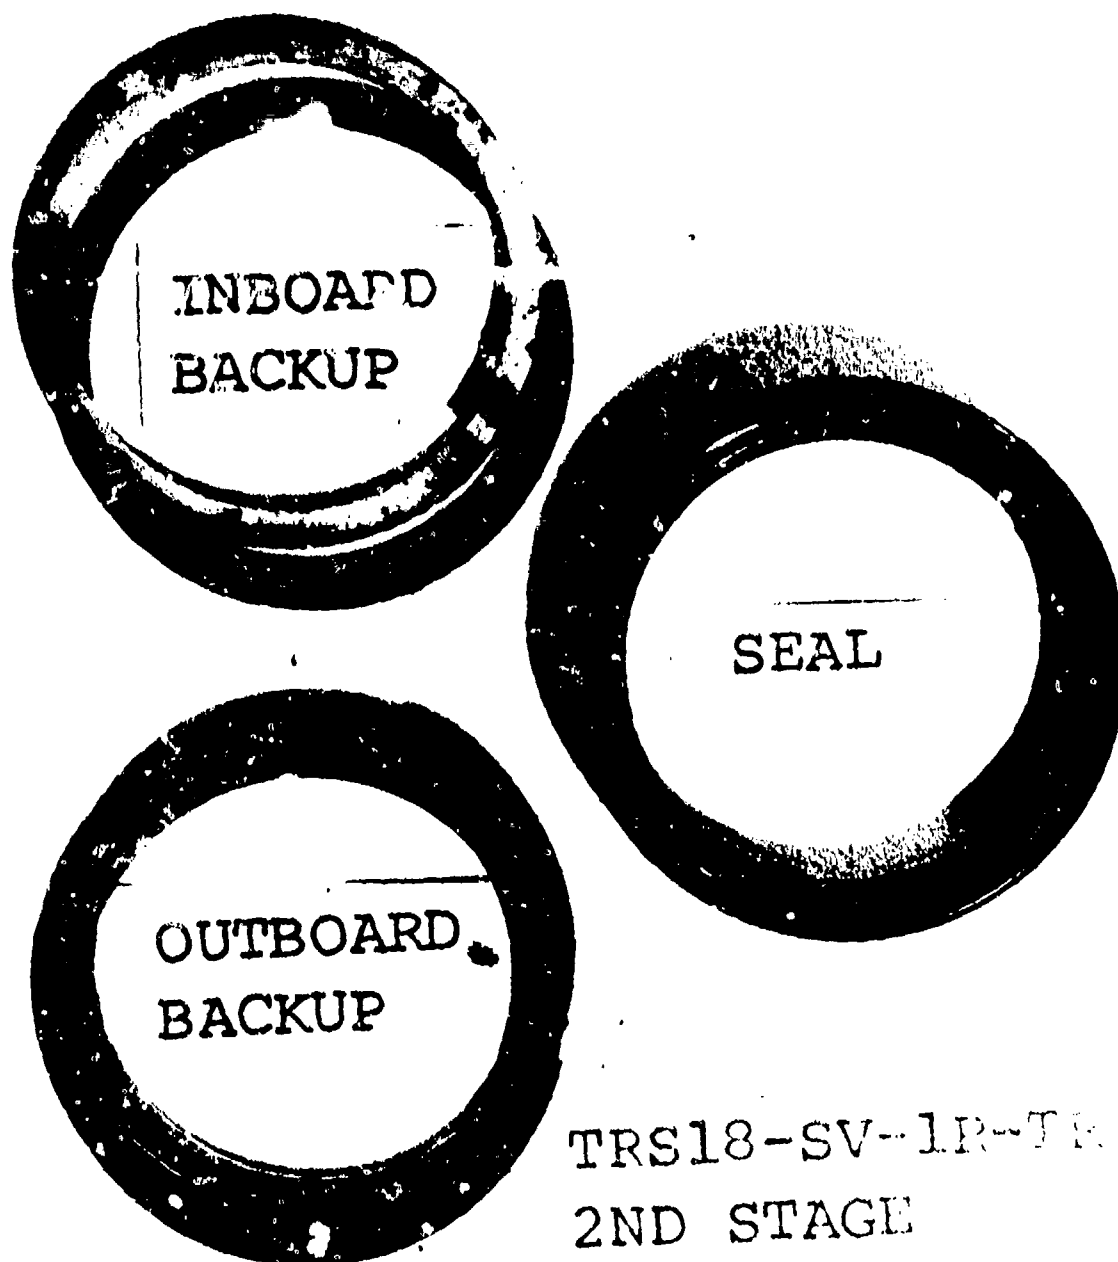
Figure 141. Candidate TRS18-SV (2nd Stage) After Two Stage Rod Seal Screening Test. "T" seal had very shallow axial wear pattern around ID.

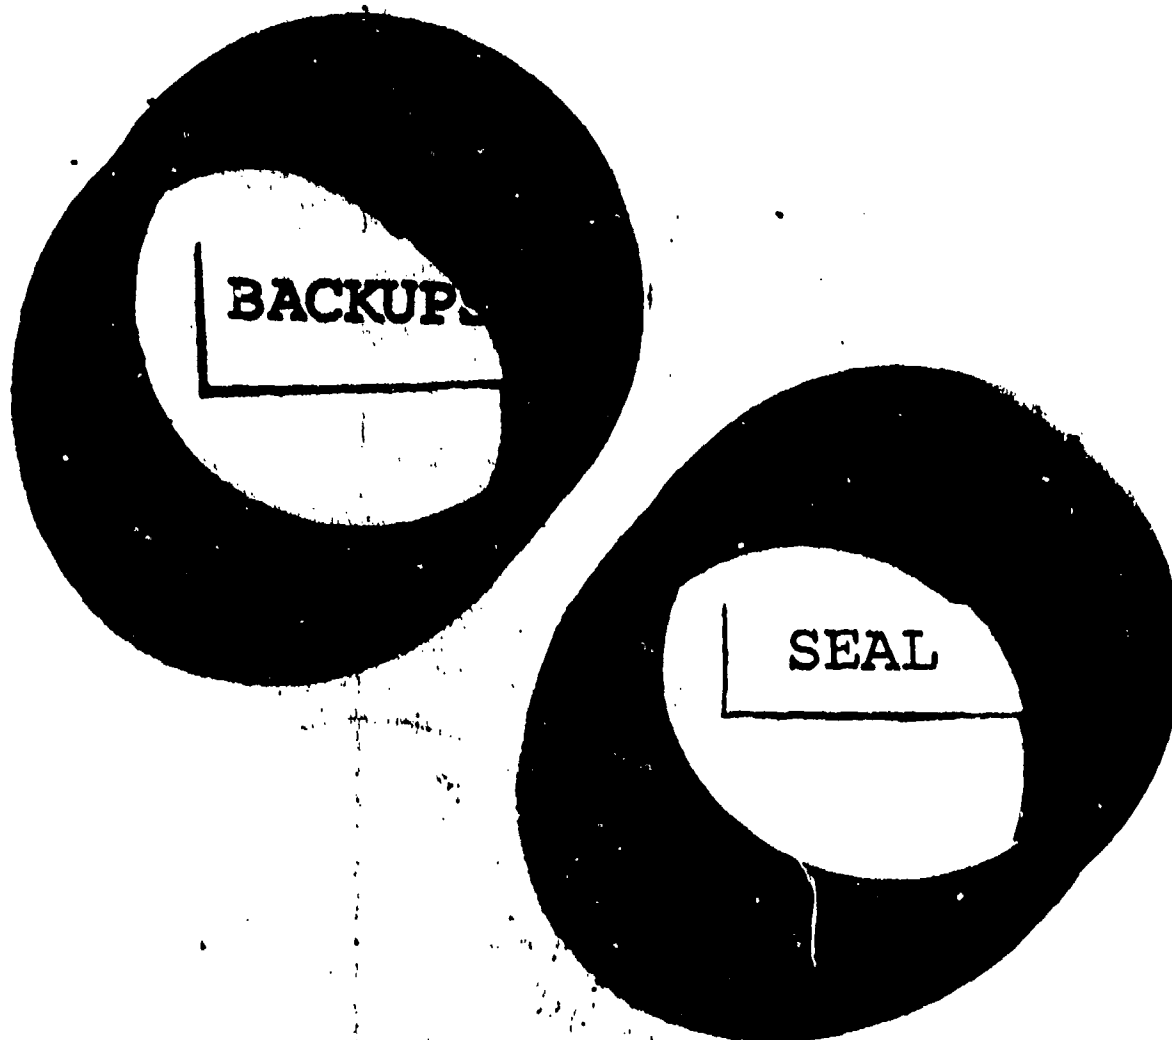
TRS21-SV-2R-TR
2ND STAGE

RESULTS: See Figures 151 and 152. Both the inboard and outboard cap seal, backups, and elastomers had minimum wear. The rod had a light to moderate circumferential axial wear pattern which was most pronounced in the area contacted by both seals during cycling. There was no evidence of leakage. Very little residue had collected between the seals. Diametral clearance for the outboard seal was .0039 and for the inboard seal was .0022. The bore of the end cap had an unusual very smooth "lapped" wear pattern.

Figure 152. Candidate TRS21-SV (2nd Stage) After Two Stage Rod Seal Screening Test. Two stage backup and "Plus" seal are Shamban Code 19 material.

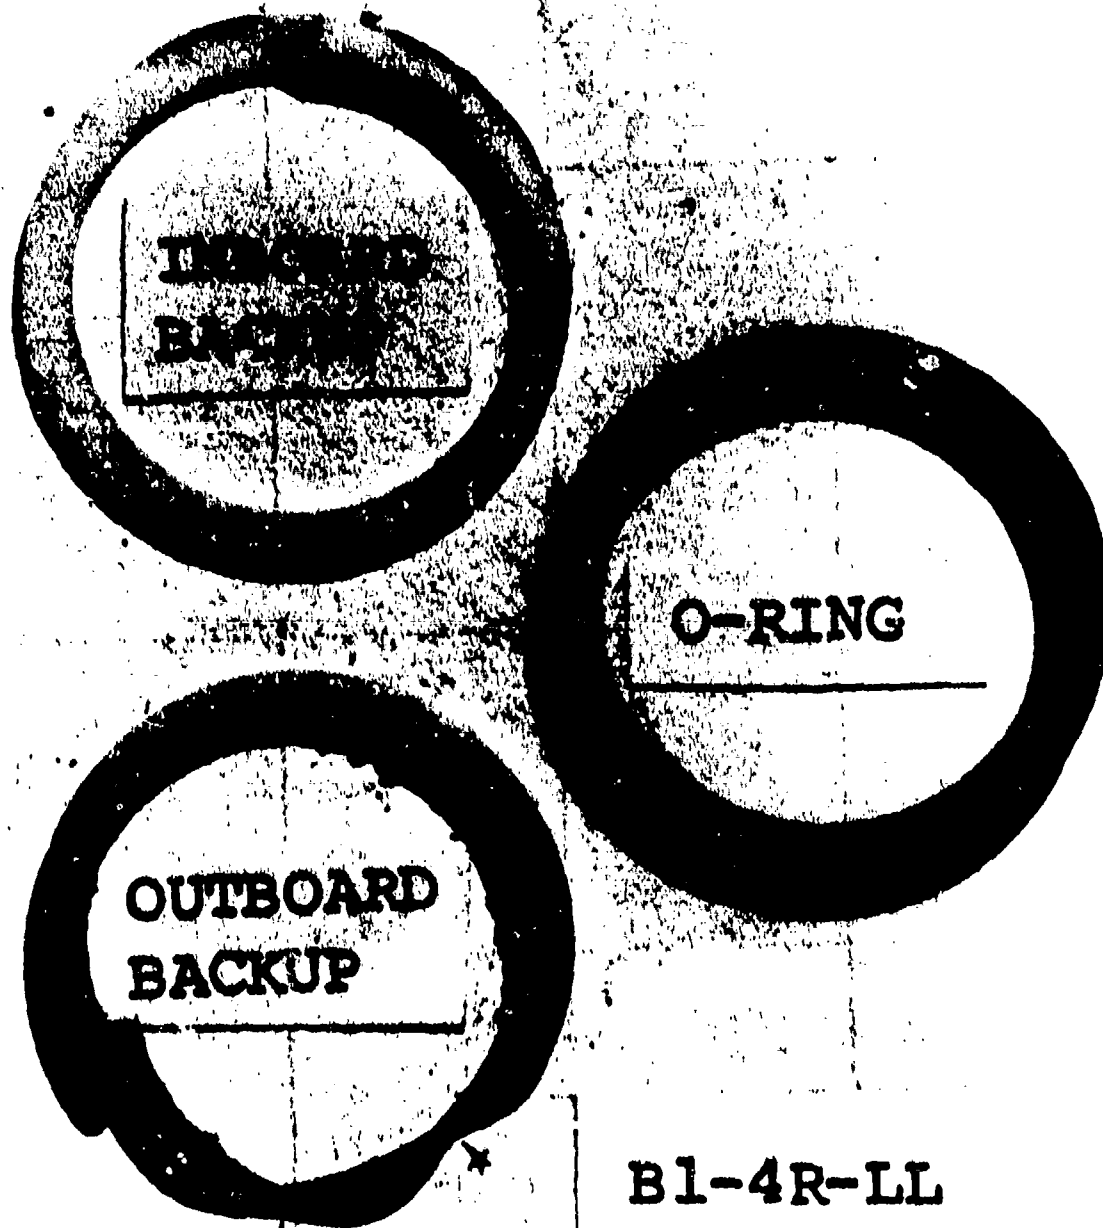
B1-4R-LL

See Figure 154. The outboard backup is nearly worn thru in two locations. The O-ring shows very light nibbling on the ID and would be classified as good condition. The rod has minimal wear and exhibits only one very small mark which is deeper than the original 12-16 RMS finish. Leakage was 30.15 ml static, .05 ml low temperature, and 187 ml dynamic. Diametral clearance was .0030.

Figure 154. Candidate B1 After Long Life Test. Note severely worn areas on backup. O-ring is in good condition.

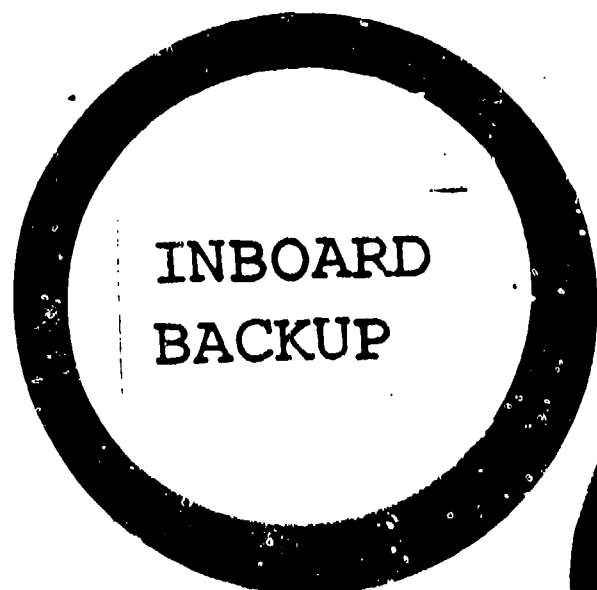
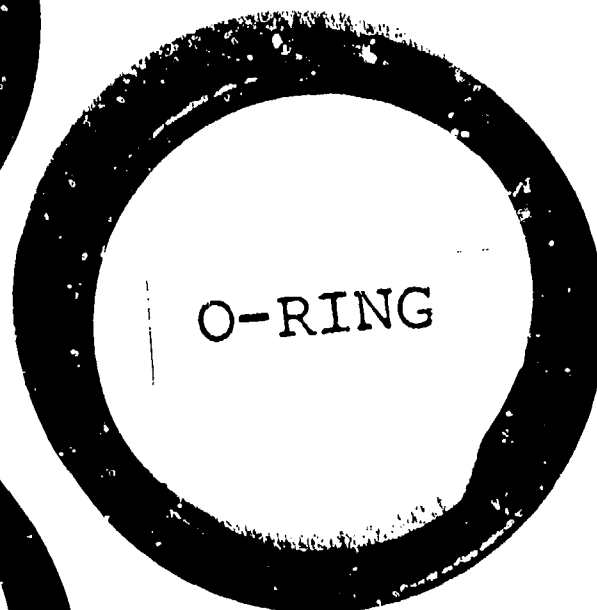
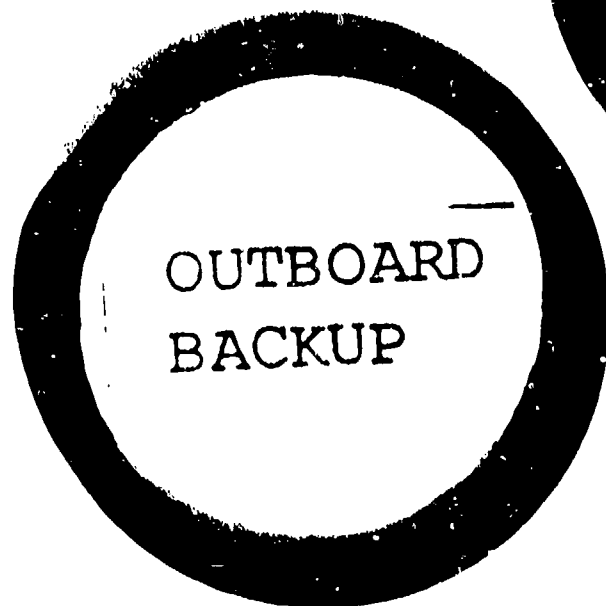
B35-1F-1

See Figure 156. No damage occurred to the O-ring. The ID of both backups conformed to the rod diameter of .998 inches. The cross section of the outboard backup was .1097 versus .108 minimum for a new backup. Wear on rod is greatest where both the seal and scraper 1 and 2 percent strokes occurred. Depth of wear is sufficient to obliterate 12-15 RMS finish marks. In areas where only the rod or the scraper passed, wear is low to moderate. Leakage was 0 static, 1.95 ml low temperature, and 6.0 ml dynamic. Diametral clearance was .0030.

Figure 156. Candidate B35 After Long Life Test. O-ring is in excellent condition after 13.31×10^6 endurance cycles.

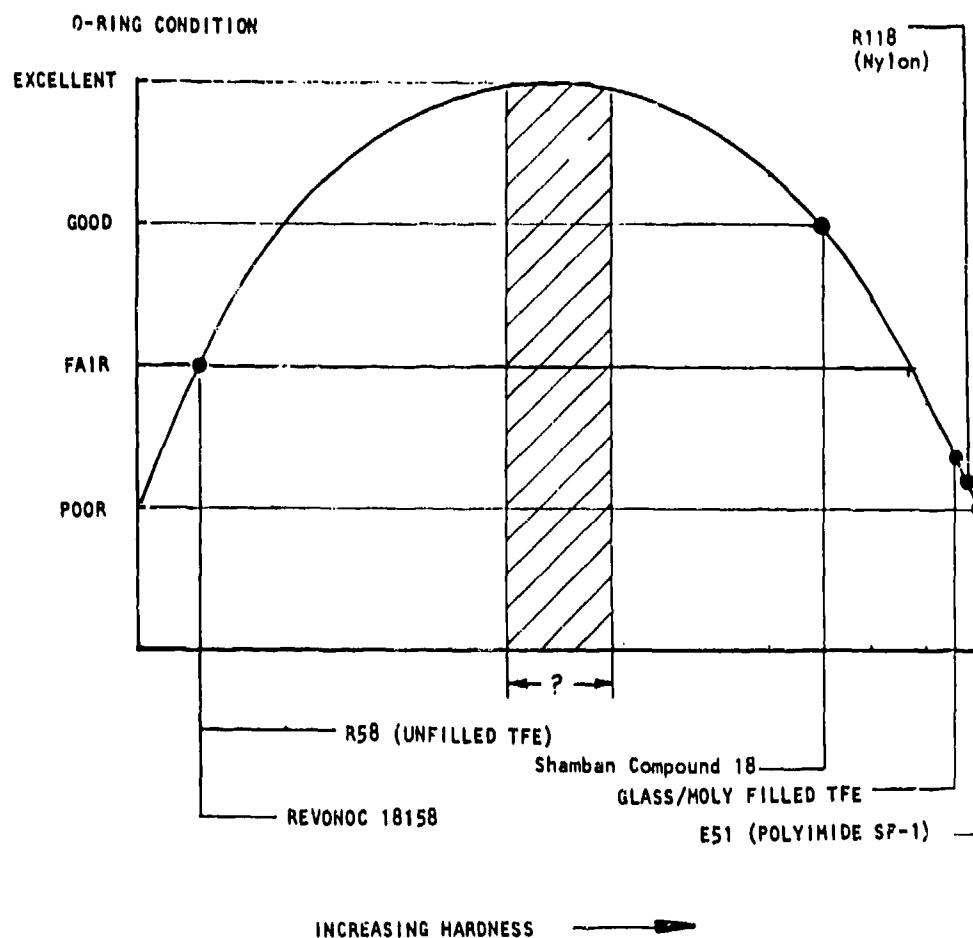
Comparing the first five backups which are similar except for material, the backup diametral clearance does not appear to be related to O-ring condition. A better correlation can be made with the relative cold flow of the material. The materials with no cold flow gave poor O-ring condition. The materials with high cold flow gave only fair O-ring condition. The Shamban compound 18 (proprietary filled Turcon) material with low cold flow gave a good O-ring condition. Figure 169 attempts to graph this relationship using hardness as the X-axis parameter and O-ring condition as the Y-axis parameter. This graph suggests that the ideal backup ring material lies between unfilled TFE with Rockwell hardness of R58 and polyimide (SP-1) with Rockwell hardness of E51.

Figure 169. O-Ring Condition Versus Backup Rockwell Hardness
